EMERGENCY IMAGING

Keith D. Hentel, MD, Elizabeth K. Weidman, and Kevin Mennitt, MD

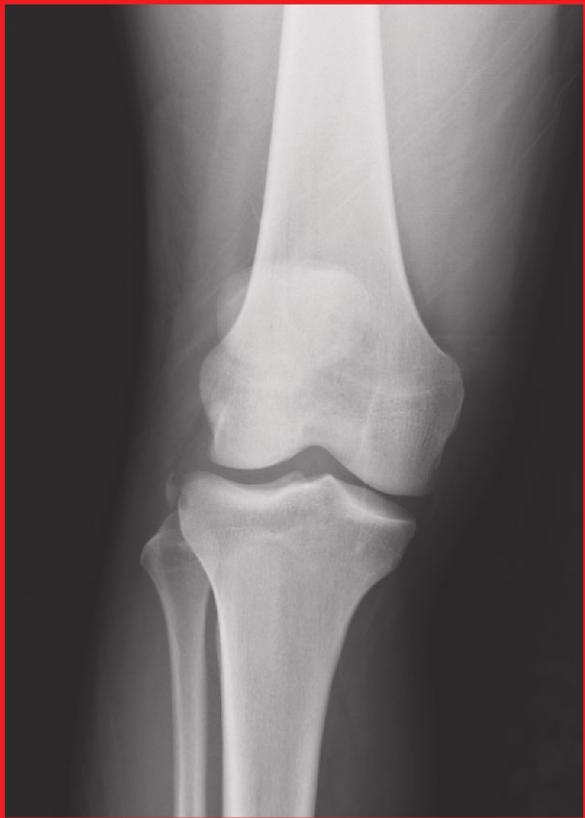
FIGURE 1

A 36-year-old man presents to the ED with knee pain after a skiing accident. Physical exam reveals joint effusion and pain along the lateral aspect of the right knee. Further examination is limited by pain and guarding. AP (Figure 1) and lateral (Figure 2) radiographs of the right knee are obtained.

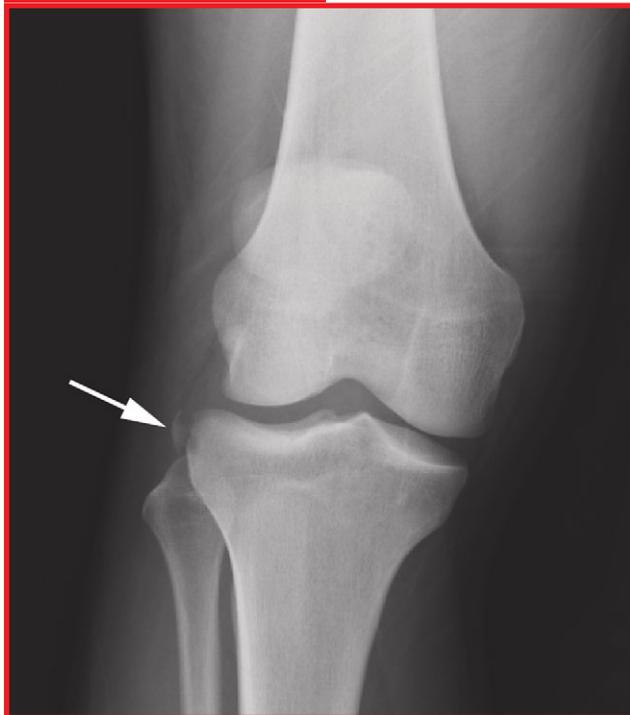
FIGURE 3

The AP view of the right knee (Figure 3) reveals an elliptical bone fragment parallel to the lateral tibial rim (white arrow), indicating a Segond fracture. The fracture is not visualized on the lateral view of the knee (Figure 4). However, the lateral view does demonstrate a large joint effusion (white asterisk), which in the setting of trauma indicates the presence of an intra-articular injury.

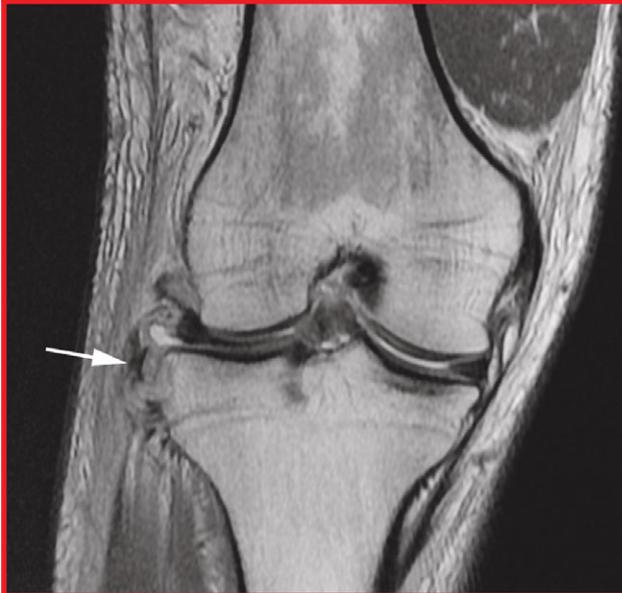
FIGURE 5

this patient (Figure 5) demonstrates the avulsed cortical fragment (white arrow) that has been pulled off by the lateral joint capsule. A sagittal fat-suppressed proton density-weighted image (Figure 6) illustrates complete disruption of the ACL (white arrows), as well as the joint effusion (black asterisk) that was seen on the lateral radiograph. No meniscal injury was present in this patient.
